KERAKOLL S.p.A.Structural reinforcement systems

Shake table tests on masonry walls retrofitted with Textile Reinforced Mortar

Experimental investigation on the shake table

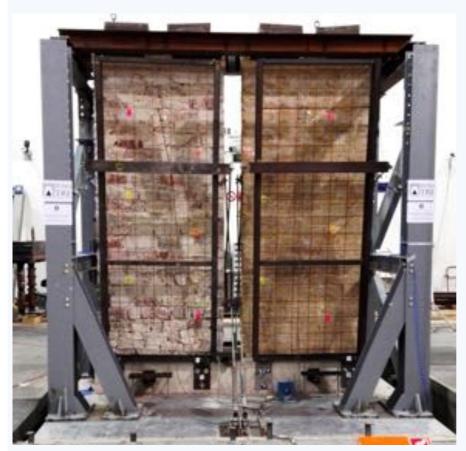
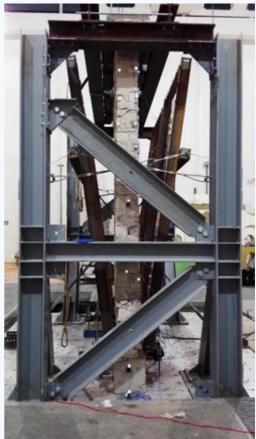
Unreinforced wall specimens on the shake table during the previous experimental investigation

Two full-scale wall specimens, 3.7m high and 25cm thick, one in **stone masonry** and one in **tuff blocks**, will be tested on the shake table. The walls are provided with a **top beam in reinforced brickwork**, having high strength steel textiles in the bed joints and with steel connectors to the walls. The testing setup includes a steel frame connected to the shake table that prevented the horizontal displacement of the top beam, leaving free rotations and upward displacements.

The seismic behaviour of the two masonry walls without reinforcement was investigated in a recent experimental investigation. Both the walls failed by the development of horizontal hinges. Test movies are available at the following links:
