## Shake table tests of a rubblestone large-scale masonry structure

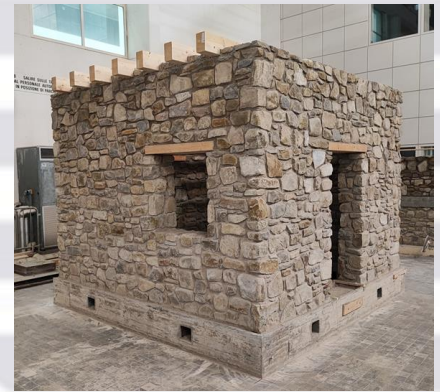
The traditional stone masonry architecture in central Italy, while emblematic of cultural heritage, demonstrated its dramatic seismic vulnerability during recent events, notably the 2016-2017 earthquake sequence. Disintegration emerged as the primary failure mode. This highlights the need of enhancing the understanding of the seismic behavior of rubble masonry constructions and of developing adequate retrofiting technologies, pivotal for preserving structural integrity and architectural distinctiveness. Within RIPARA research project, funded by Regione Lazio, the seismic behavior of a large-scale masonry structure was investigated on the shake table. Tests were carried out at ENEA Casaccia Research Centre.

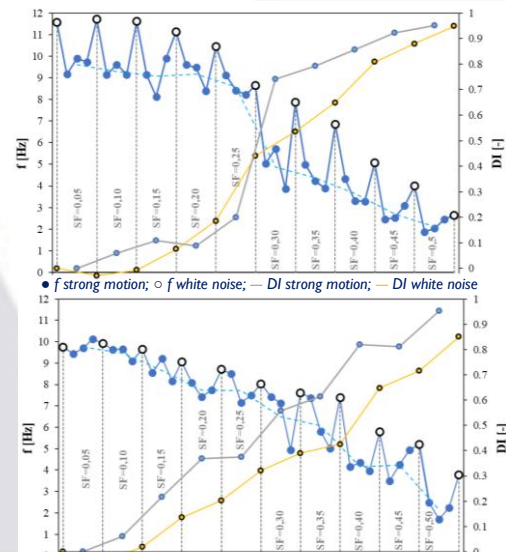
The shake table tests faithfully replicated real conditions observed in Lazio Apennine villages during the 2016-2017 seismic sequence, emphasizing the crucial role played by masonry disintegration. Thorough investigations and safeguarding interventions are pivotal to prevent catastrophic collapses, as standard rigid-body approaches might provide unconservative estimates of seismic capacity. The structure exhibited a linear behavior until  $PGA=0.20g$ , followed by a stiffness reduction and the initiation of failure, which took place at  $PGA=0.50g$ . Frequency reduction with increasing PGA agreed with surveyed damage. This work contributed to the understanding of the seismic behavior of rubble masonry structures, and provided an experimental benchmark for validating/calibrating structural analysis models and developing seismic retrofiting techniques.
