Structural assessment of Late Neolithic Sa Covaccada Dolmen in Mores (SS), Sardinia

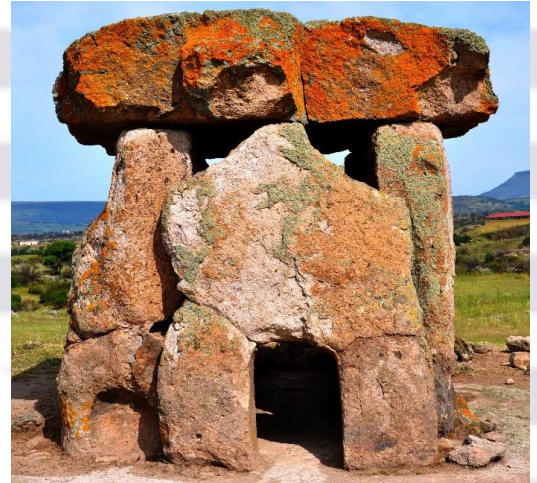
The Dolmen of Sa Covaccada dates back to the first half of the 3rd millennium BC and is considered one of the most important megalithic structures in Sardinia. Due to the severe deterioration of trachyte surfaces, the collapse of some portions of the capstone, and the extensive crack pattern, the monument underwent a first restoration in 2011, but still requires important retrofitting. The stability of the top slabs is a main concern, but it has never been assessed to date. This work investigates the structural behaviour of the monument with different engineering tools.

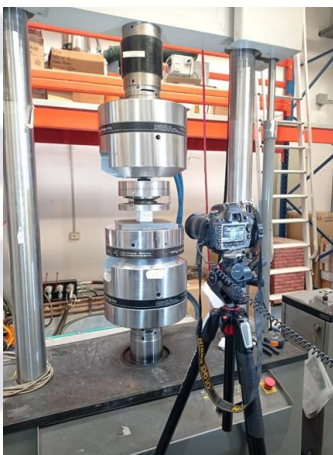
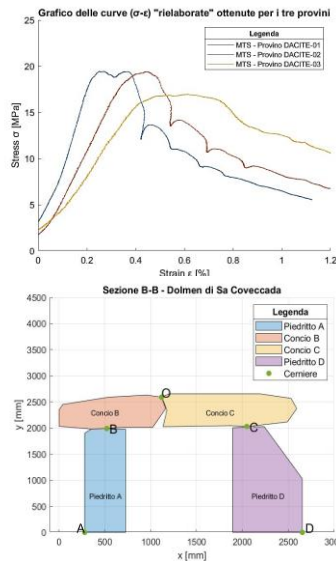
Following the inspection activities carried out in July 2023, compression tests were performed on three cubic specimens for the mechanical characterization of the stone. Tests were carried out in the Laboratory of Structures of Roma Tre University using DIC technology. Then, structural analyses were performed at two levels: an analytical model and a discrete element model (DEM, using UDEC software) were developed for the assessment of the collapse mechanisms of significant transversal cross-sections of the dolmen. A FEM model was built to investigate the stress field on the longitudinal orthostats and to identify local stress concentrations associated with cracks.

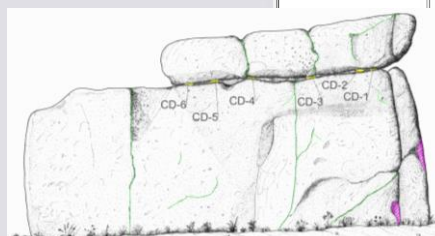
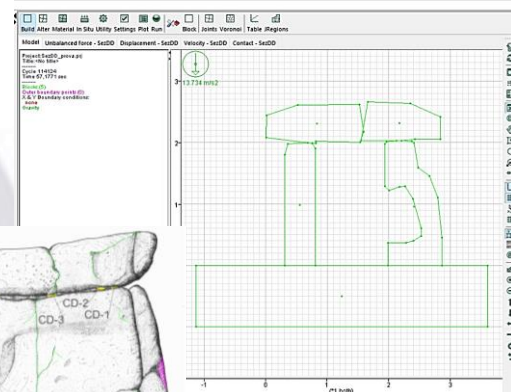
The failure mode and collapse multipliers provided by the analytical approach were validated by DEM simulations. The accurate representation of block geometry, contact points and crack pattern resulted crucial for a thorough structural assessment of the dolmen. A non-invasive, compatible and fully reversible restoration work was proposed to reduce the stress concentrations and detailed monitoring of the crack pattern was recommended. Further DEM analyses with 3D models are underway to develop a deeper understanding of the structural behavior of the monument.
